MT. HOPE LAKE DAM

NJ 00464

6 PHASE 1 INSPECTION REPORT
NATIONAL DAM SAFETY PROGRAM.

Mt. Hope Lake Dam (NJ-00464)
Passaic River Basin, White Meadow Brook,
Morris County, New Jersey.
Phase 1 Inspection Report.

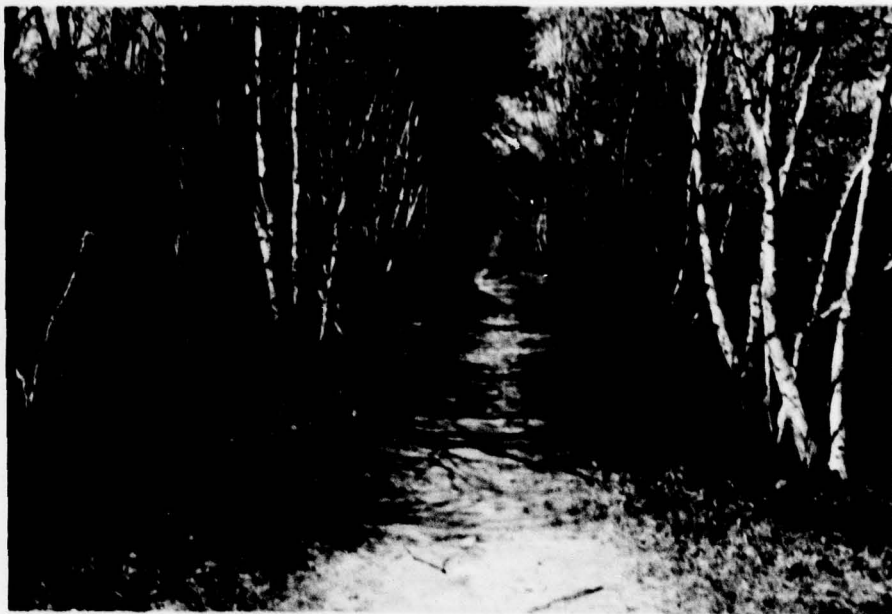
PHOTO 7
CREST OF DAM
